Outside Filament-wound Reinforcement: A Novel Configuration for FRP Bridge Decks

Peng Feng, Leiping Ye, Tianhong Li, Qianli Ma

Key Laboratory of Structural Engineering and Vibration of China Education Ministry
Department of Civil Engineering, Tsinghua University
Beijing, 100084, P.R. China

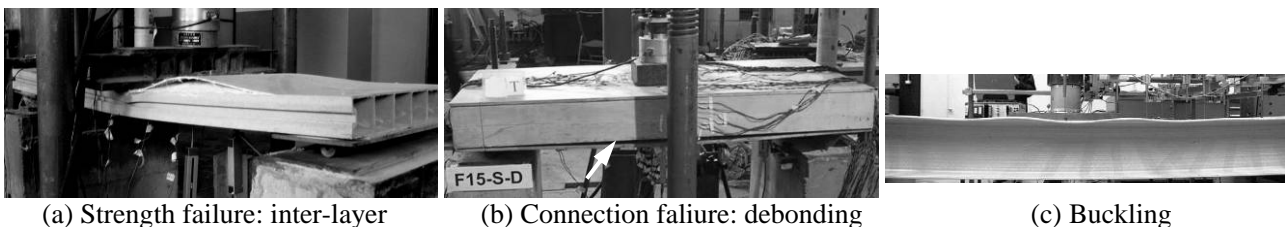
Figure 1 Failure modes of FRP decks

In tests of existing FRP bridge decks, the apparent failure characteristics--cracking, fiber breaking, debonding and delaminating--were observed as the loading capacity fell. Each failure mode has a corresponding loading capacity value. The damage always starts at the lowest mode, which leads to the failure of the whole deck. Therefore, it is reasonable to believe that deck performance can be improved by preventing these failure modes. According to the failing origin, the failure modes can be classified into strength failure, connection failure, and buckling. (i) **Strength failure** is the failure caused by the stress of FRP reaching the strength of material, including tensile, compressive, in-plane shear, bending, and inter-layer. The tensile and compressive failure in the weak direction, in-plane shear failure, bending failure, and inter-layer failure are frequent. An inter-layer strength failure example is shown in Figure 1(a). (ii) **Connection failure** is caused by the connection break FRP components, including debonding, bolt shear, and bolt bearing. The adhesive bond is always employed for the existing FRP deck, so the debonding often occurs, as shown in Figure 1(b). This mode is undesirable because the FRP isn't utilized fully and breaks suddenly. (iii) **Buckling failure** is caused by the instability of the compressed FRP elements. The obvious buckling waves can be seen before the FRP elements fail in this mode as illustrated in Figure 1(c). As FRP is linear elastic, the FRP elements usually don't reach the maximum loading capacity when the local buckling occurs. In most cases, buckling failure goes together with the other two failure modes. This can occur in two ways: buckling failure precedes the other two, and buckling occurs after the other two. The former is the buckling failure strictly. All three failure modes may occur sequentially in the tests, even influence other each. But the key failure, which causes the loading capacity falling, is what concerns us. Usually, tensile and compressive failure in the weak direction, delaminating, in-plane shear failure, and debonding between components acted as the key modes in the tests of the existing FRP decks. Therefore, it is a way for improving the performance of FRP decks to prevent or defer these failure modes by configuration design, which is the main reason for the use of OFR.

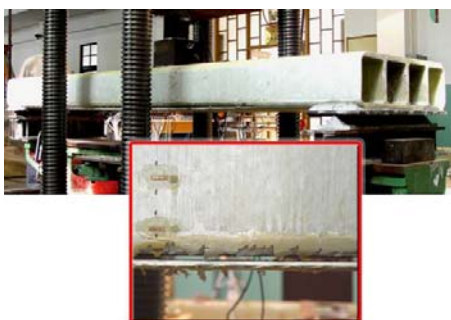
Figure 5 Debonding of HD0

HD group was loaded in two cases: 4-point line bending to estimate the stiffness and central point loading to simulate the wheel load. HD0 and HDW3 loaded to failure under Case 2. For HD0, the debonding between tubes and bottom plate occurred suddenly when the central load reached 485kN as shown in Figure 5. Before it, HD0 was linear elastic almost. HDW3 had a little ductile failure process by the punching failure under the load position as shown in Figure 6. It started from the load of 590kN. The maximum load reached 618kN. Comparing HDW3 and HD0, the load capacity had a 26.4% increase. HDW5 didn't fail when the load went over the maximum value of the other two in Case 2. Their load-deflection curves are compared in Figure 7. HDW5 was loaded to failure at 1737kN in Case 1. Before failure, the deck deformed obviously as shown in Figure 8(a). The deck was broken in bending, and the tubes were crushed as shown in Figure 8(b) and (c). In this mode, FRP is utilized effectively although it failed brittle. Comparing three decks, the ultimate strength increase with the thickness of the OFR layer is shown.
